# Manhole Inspection Summary

Manhole # S3500\_006MH

Insp Date: **1/24/07 12:57 PM**

**Location** Address: **2209 HUNTER ST**

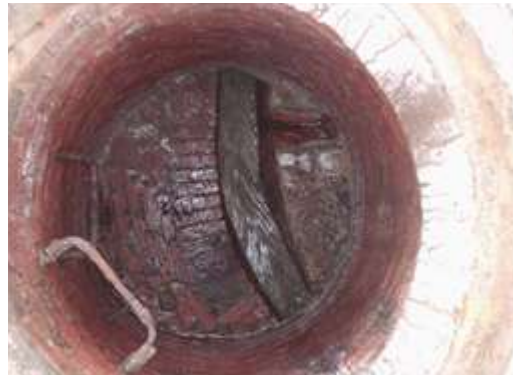
Top View

Corroded steps. Evidence of surcharge - Bench debris.

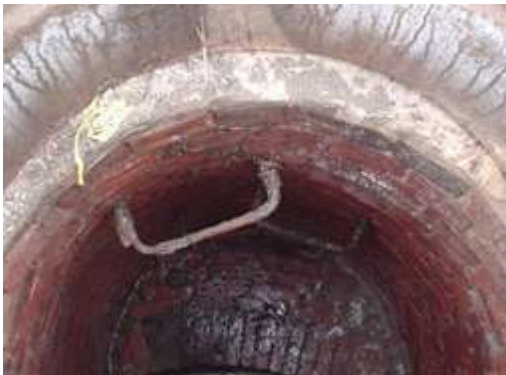
Defect

Frame offset. Corbel deterioration and infiltration.

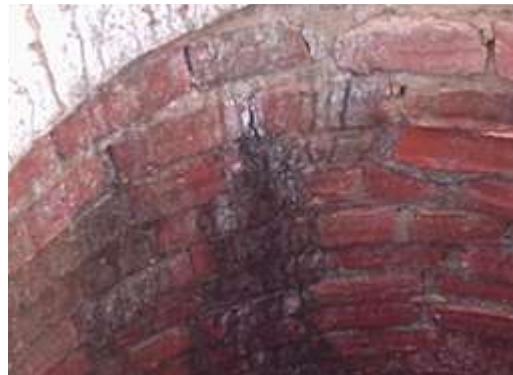
Defect

Corbel deterioration and infiltration.

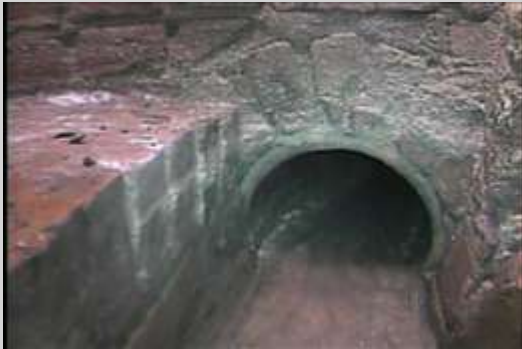
### 8 in. Circular Gravity Sewer Pipe Out @ 12 O'Clock

Deposits: ☐ None ☐ Mud ☐ Sludge ☐ Debris ☒ Grease

Silt Depth: **0** (in.) Deposits Extent: **Light**

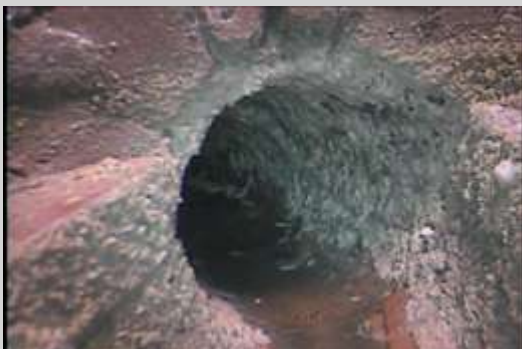
### 8 in. Circular Gravity Sewer Pipe In @ 2 O'Clock

Deposits: ☐ None ☐ Mud ☐ Sludge ☐ Debris ☒ Grease

Silt Depth: **0** (in.) Deposits Extent: **Light**
